# Test Report.

Report No.: **TR 1986766\_A**  
 Creation date **2019-05-29**

Order content	Test of two paint systems
Test item/Sample	zinc spray layers
Date of order	2016-07-20
Samples submitted on	2016-07-20
Order number	-
Testing period	2016-07-22 to 2016-10-24
Editor	Joachim Ströber, T. +49 911 655 5707

The „KompetenzZentrum Oberflächentechnik“ was commissioned to perform a test at test sample plates with two paint systems. Additionally to the adhesive strength, the corrosion resistance according to DIN EN ISO 9227-NSS and a condensate climate test according to DIN EN ISO 6270-2 were tested.

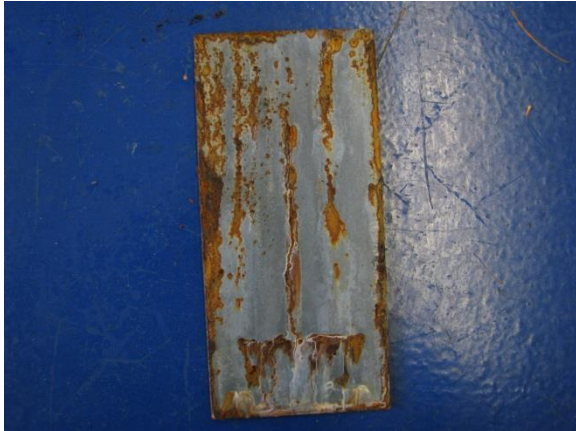
**Picture 1**  
Zinc 240 20-30µm after 720h salt spray test

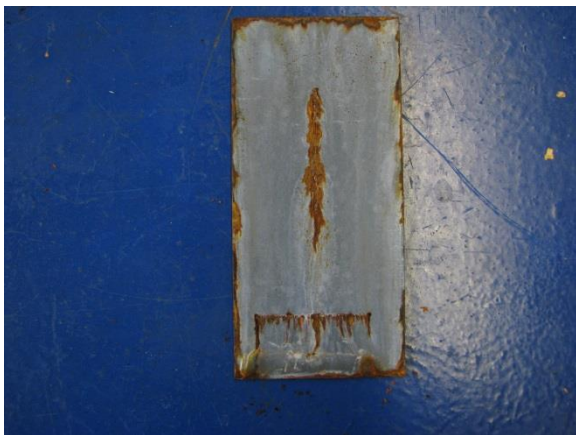
**Picture 3**  
Zinc 240 30-50µm after 720h salt spray test

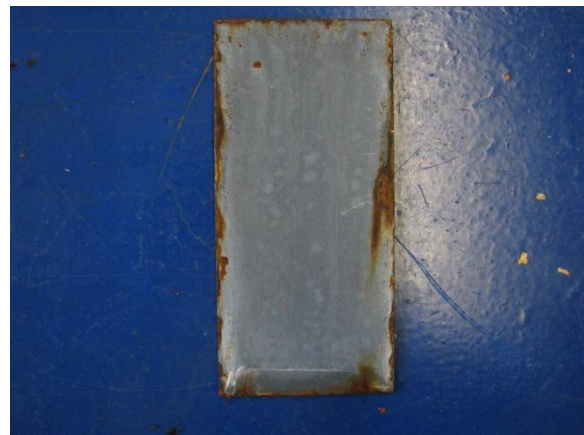
**Picture 4**  
Zinc 240 30-50µm after 720h salt spray test

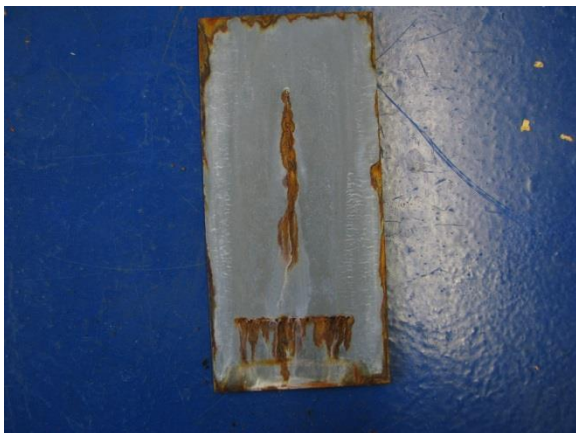
**Picture 5**  
Zinc 240 70-90µm after 720h salt spray test

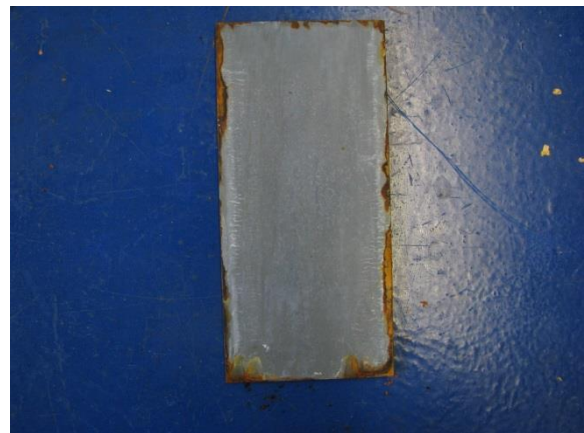
**Picture 6**  
Zinc 240 70-90µm after 720h salt spray test

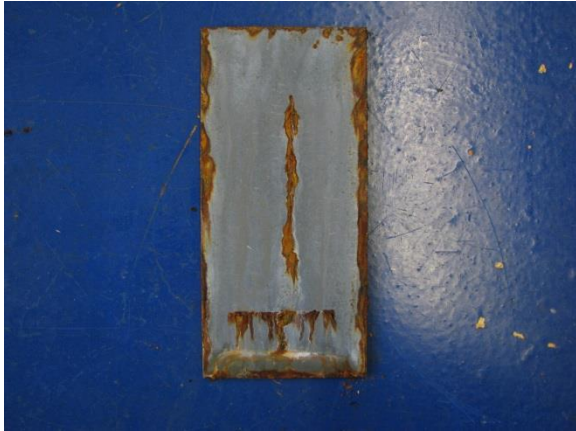
**Picture 7**  
Zinc 720 40-50µm after 720h salt spray test

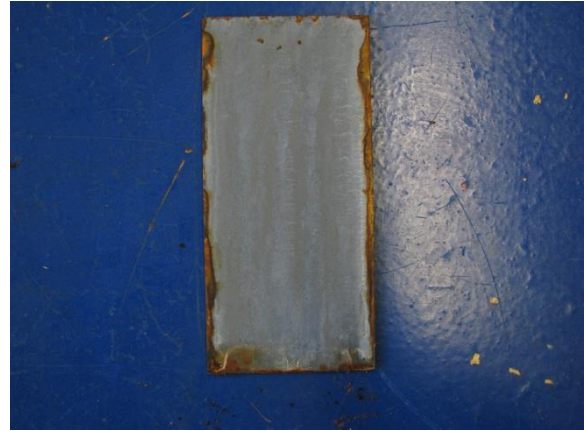
**Picture 8**  
Zinc 720 40-50µm after 720h salt spray test

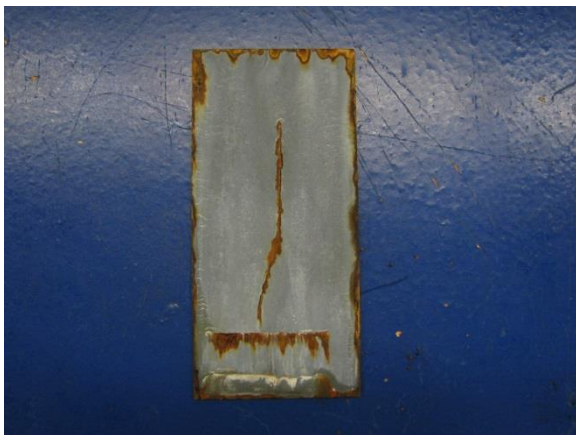
**Picture 9**  
Zinc 720 70-90µm after 720h salt spray test

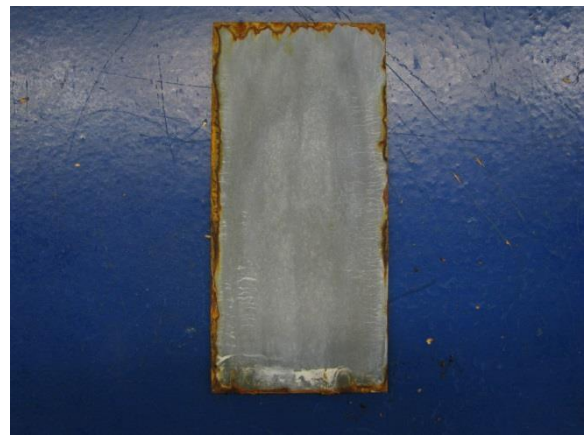
**Picture 10**  
Zinc 720 70-90µm after 720h salt spray test

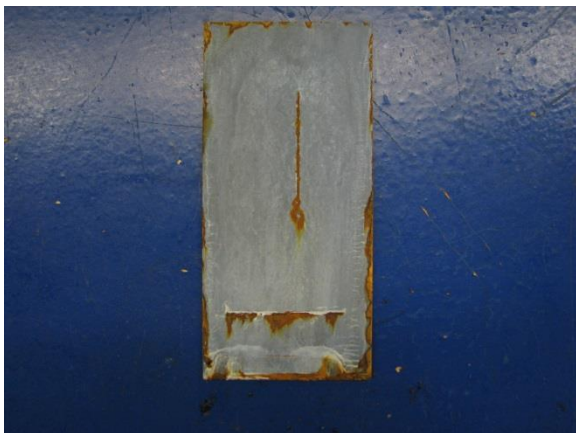
**Picture 11**  
Zinc 720 100-130µm after 720h salt spray test

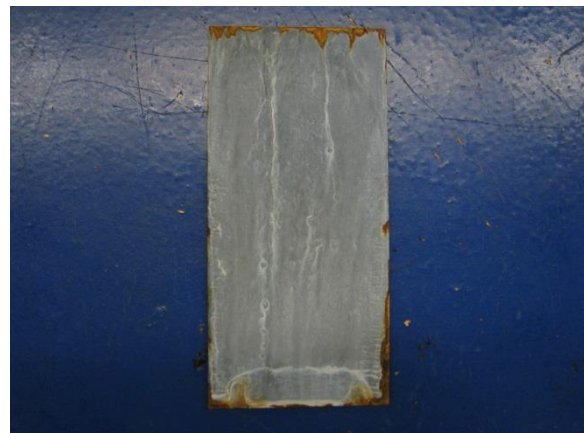
**Picture 12**  
Zinc 720 100-130µm after 720h salt spray test
